## NASA PROGRAM GEMINI WORKING PAPER NO. 5050

SPACECRAFT 8 ATTITUDE CONTROL  
ANOMALY REPORT

JUNE 27, 1966

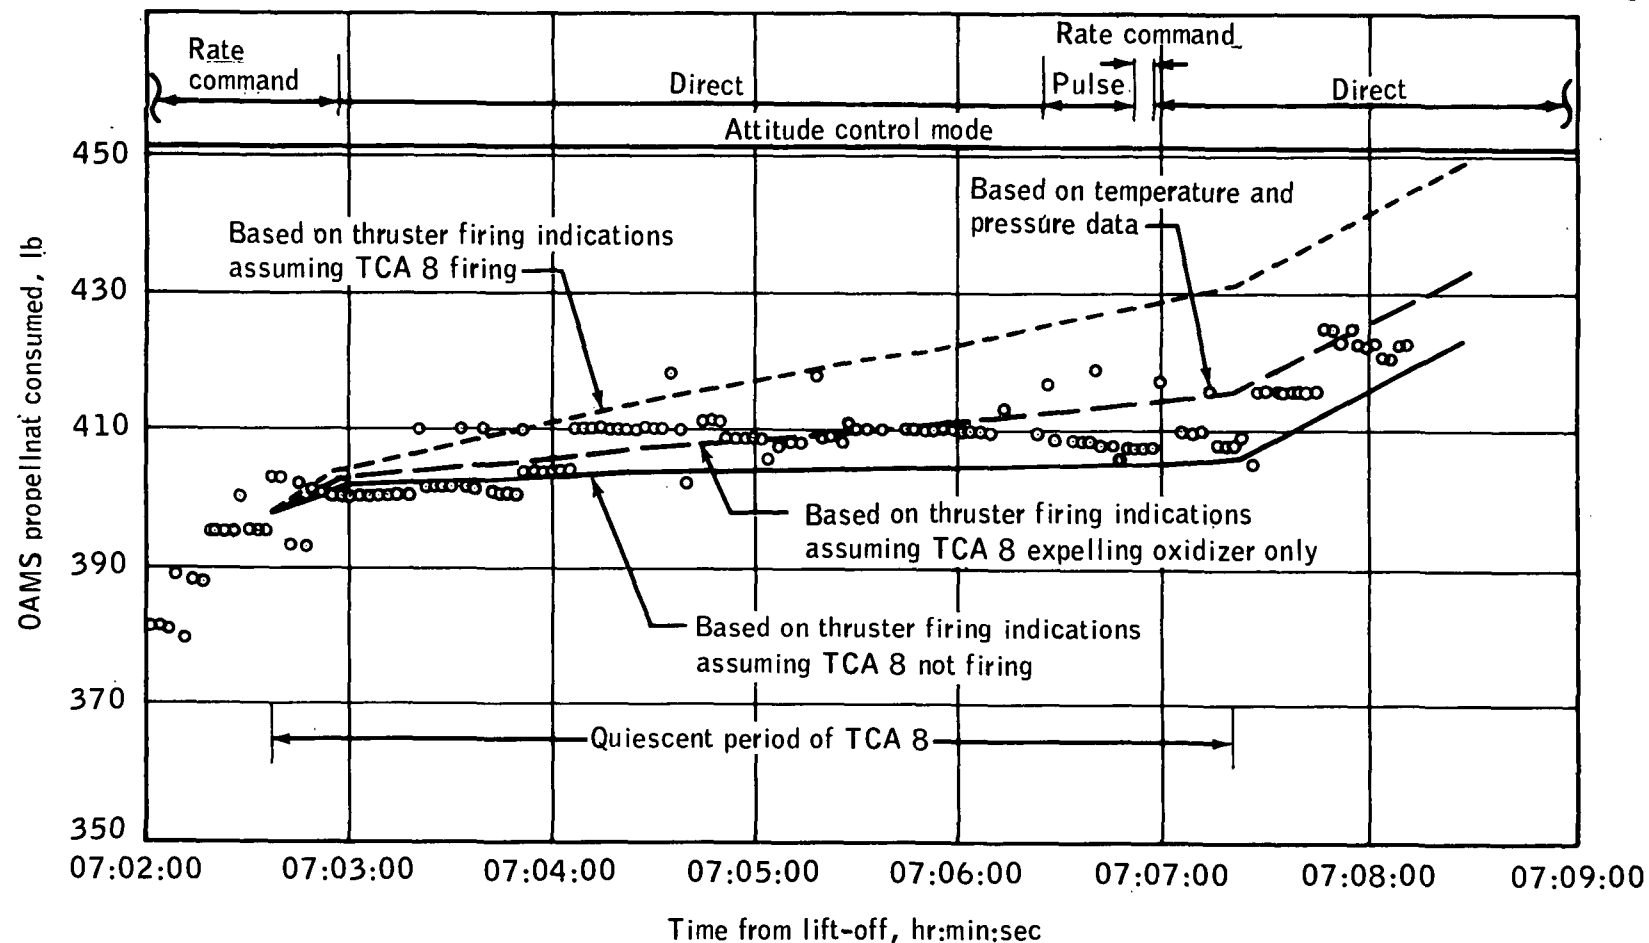
Figure 1. - OAMS propellant consumption during TCA 8 quiescent period.

(b) Figure 1 depicts for the period of degraded thrust, a comparison of propellant usage calculated from propellant temperature and pressure parameters with propellant usage calculated from thruster activities during the same period. Three curves are portrayed. The first curve is based on the measured thrust activity of TCA's 1 through 7 and assumes that both the fuel and the oxidizer valves of TCA 8 were closed. The second curve is based on the same activity of TCA's 1 through 7 plus a continuous flow of oxidizer only from TCA 8 during this period. The third curve includes flow of both oxidizer and fuel and is included to aid in the interpretation of the other two curves. (Based on rate data, the third curve is not a possible mode of TCA activity.) The effect of temperature on flow rate has been included in the calculation of the data. Based on the data, it is evident that no conclusion may be drawn which eliminates or confirms either hypothesis. However, when the rate data are considered, and in view of completely nominal GATV operation for the rest of the mission, it must be acceded that this degraded thrust probably originated from the spacecraft and, more precisely, from TCA 8.

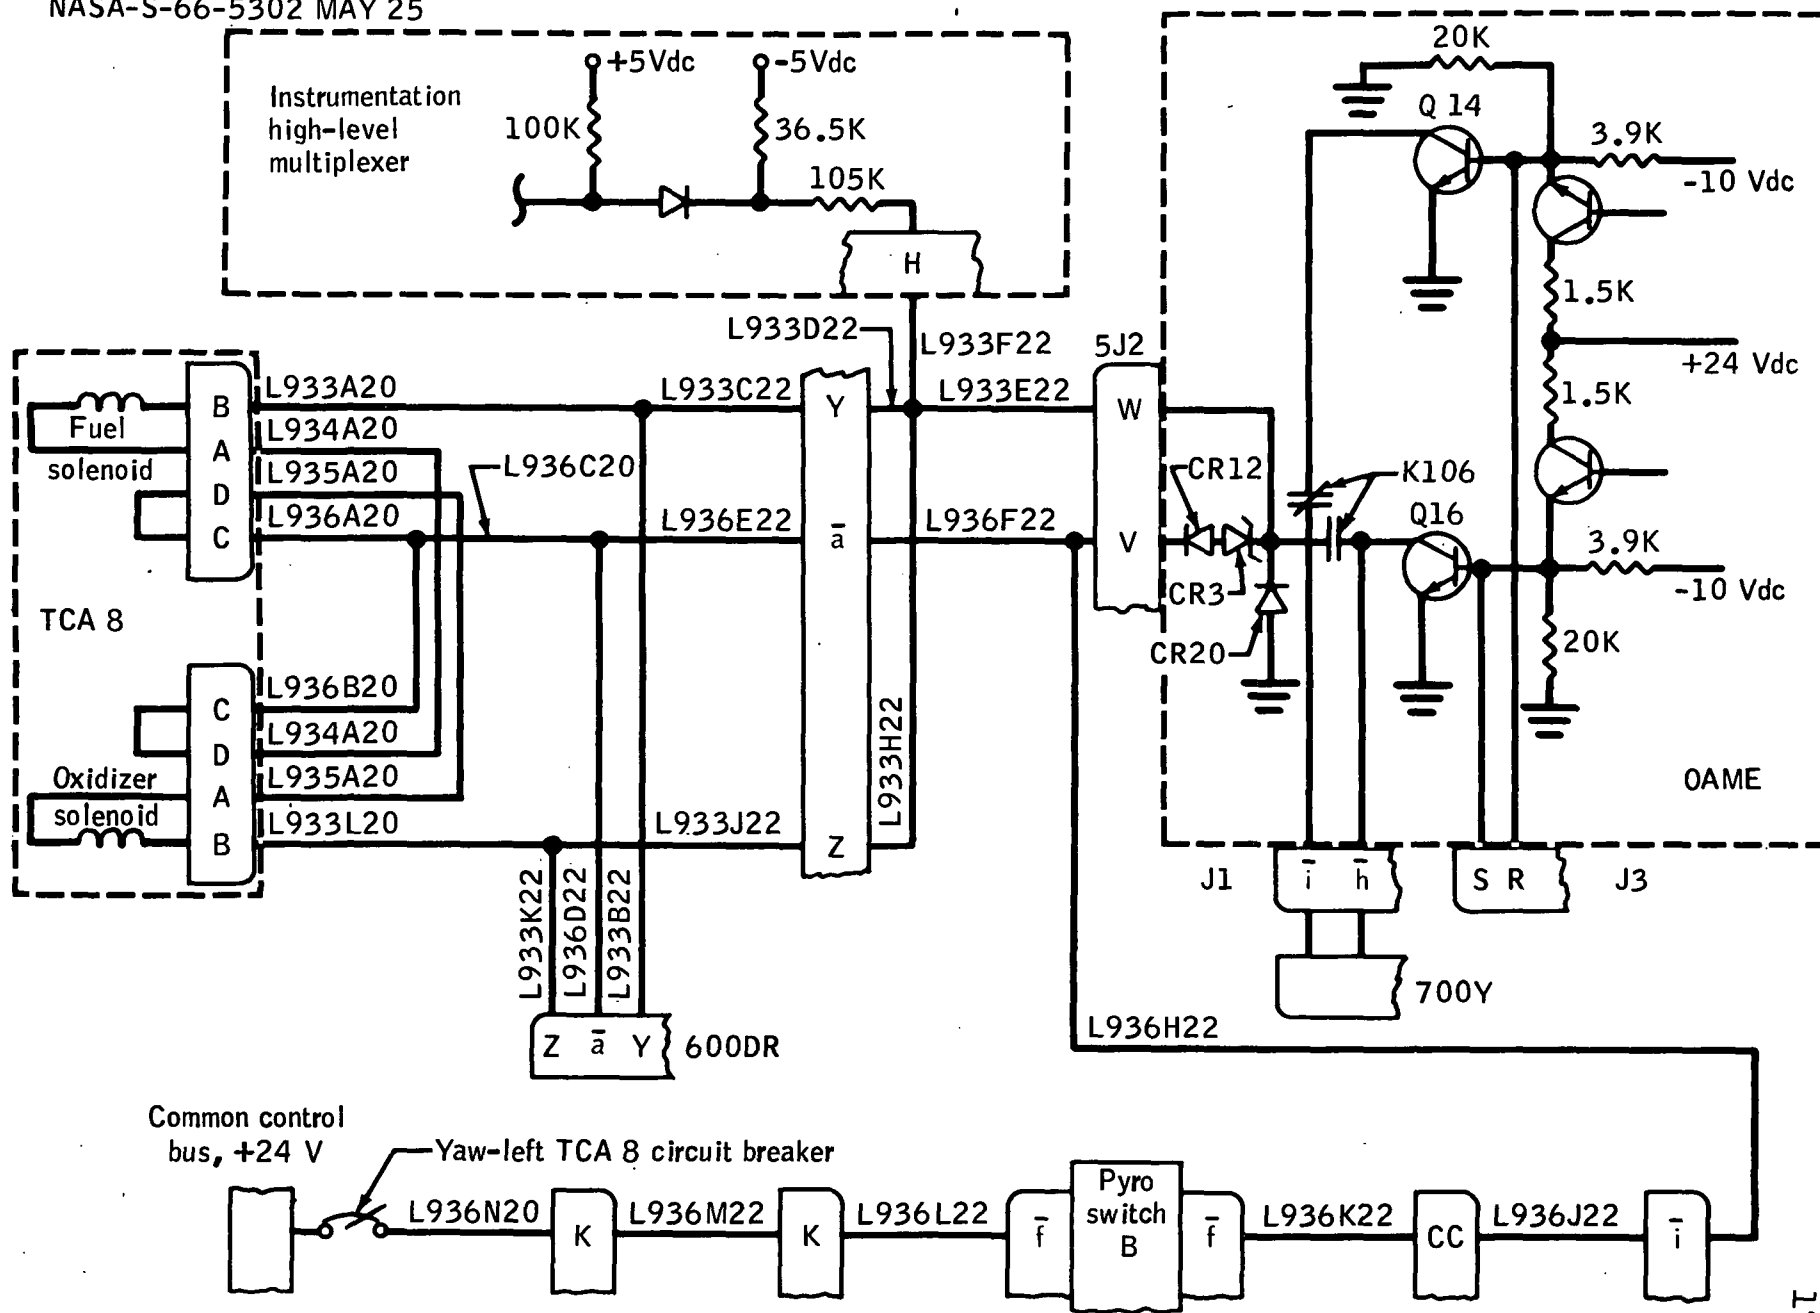
Figure 2. - Electrical circuitry associated with TCA 8.

pressure. In the following discussion, it should become clear that the cause of the inadvertent firing was a short circuit to spacecraft ground in the circuitry between the Orbital Attitude and Maneuver Electronics (OAME) package and the thruster valve solenoid coils.

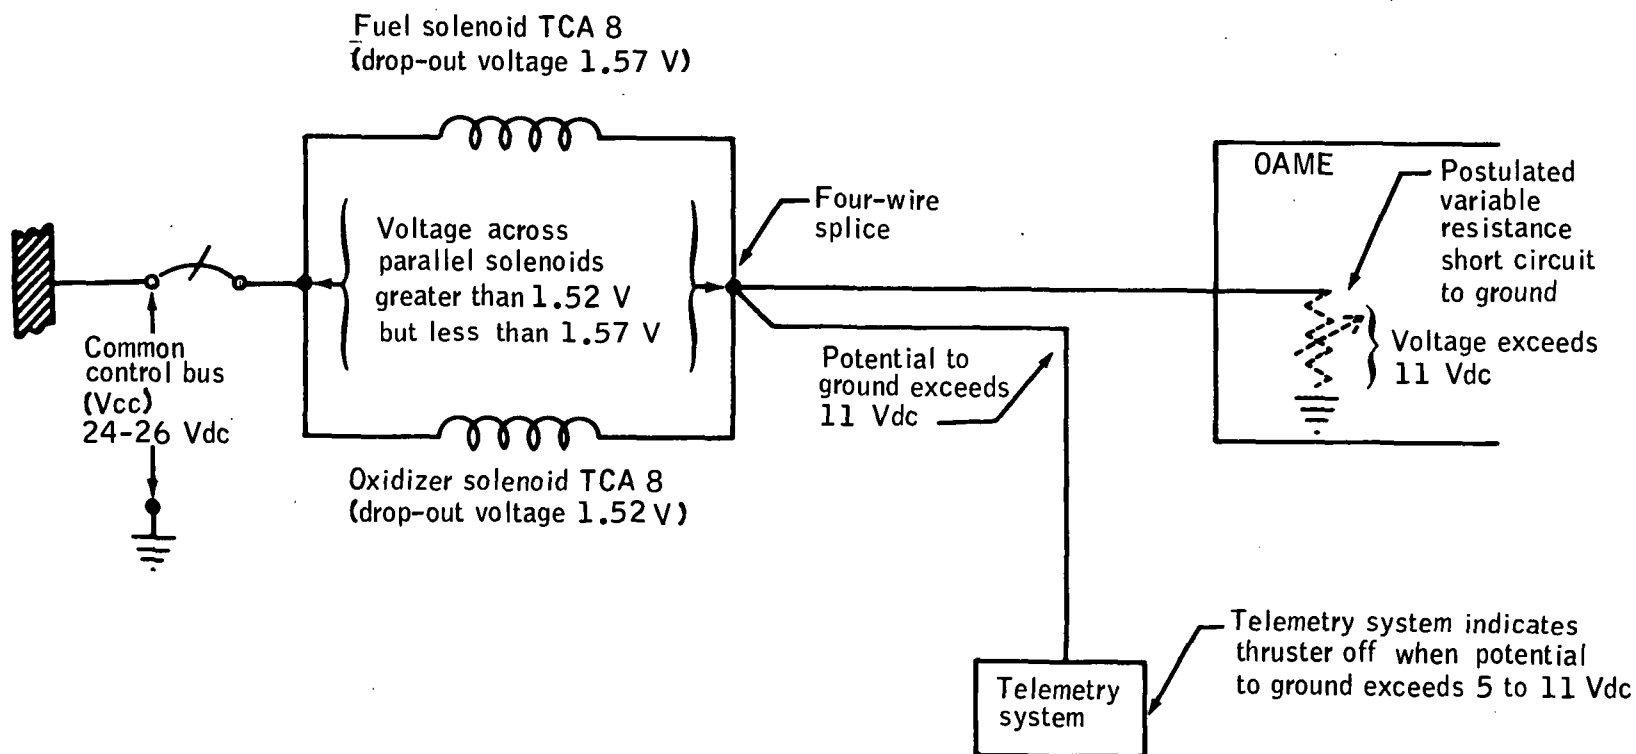
Figure 3. - Circuit conditions necessary in order for a single high-resistance short circuit to allow the oxidizer solenoid valve only to be open.

If it were possible to have a high-resistant short circuit in the OAME package that would cause the fuel solenoid to drop out without affecting the oxidizer solenoid, the resultant voltage at the input to the telemetry system high-level multiplexer would be greater than the 5- to 11-V minimum required to cause a telemetry indication of TCA 8 off. This is illustrated in figure 3. There were periods positively established during the anomaly, when the telemetry indicated a thrusting and no acceleration resulted. Because the telemetry data are not consistent with the known factors, the only possibility that the OAME package caused the Gemini VIII anomaly would have to include a simultaneous and separate failure in the telemetry system high-level multiplexer or associated wiring which resulted in the continuous telemetry indication of TCA 8 being on. The failure history of the components were reviewed and no failures were recorded which could result in a short circuit to ground. The Spacecraft 8 OAME had no failures during buildup, or pre-delivery acceptance, or PIA testing. There were no ACME problems during Spacecraft Systems Tests (SST). Component installation drawings and procedures were reviewed in detail to determine if a probability for misinterpretation existed. All drawings and procedures were found to be adequate.

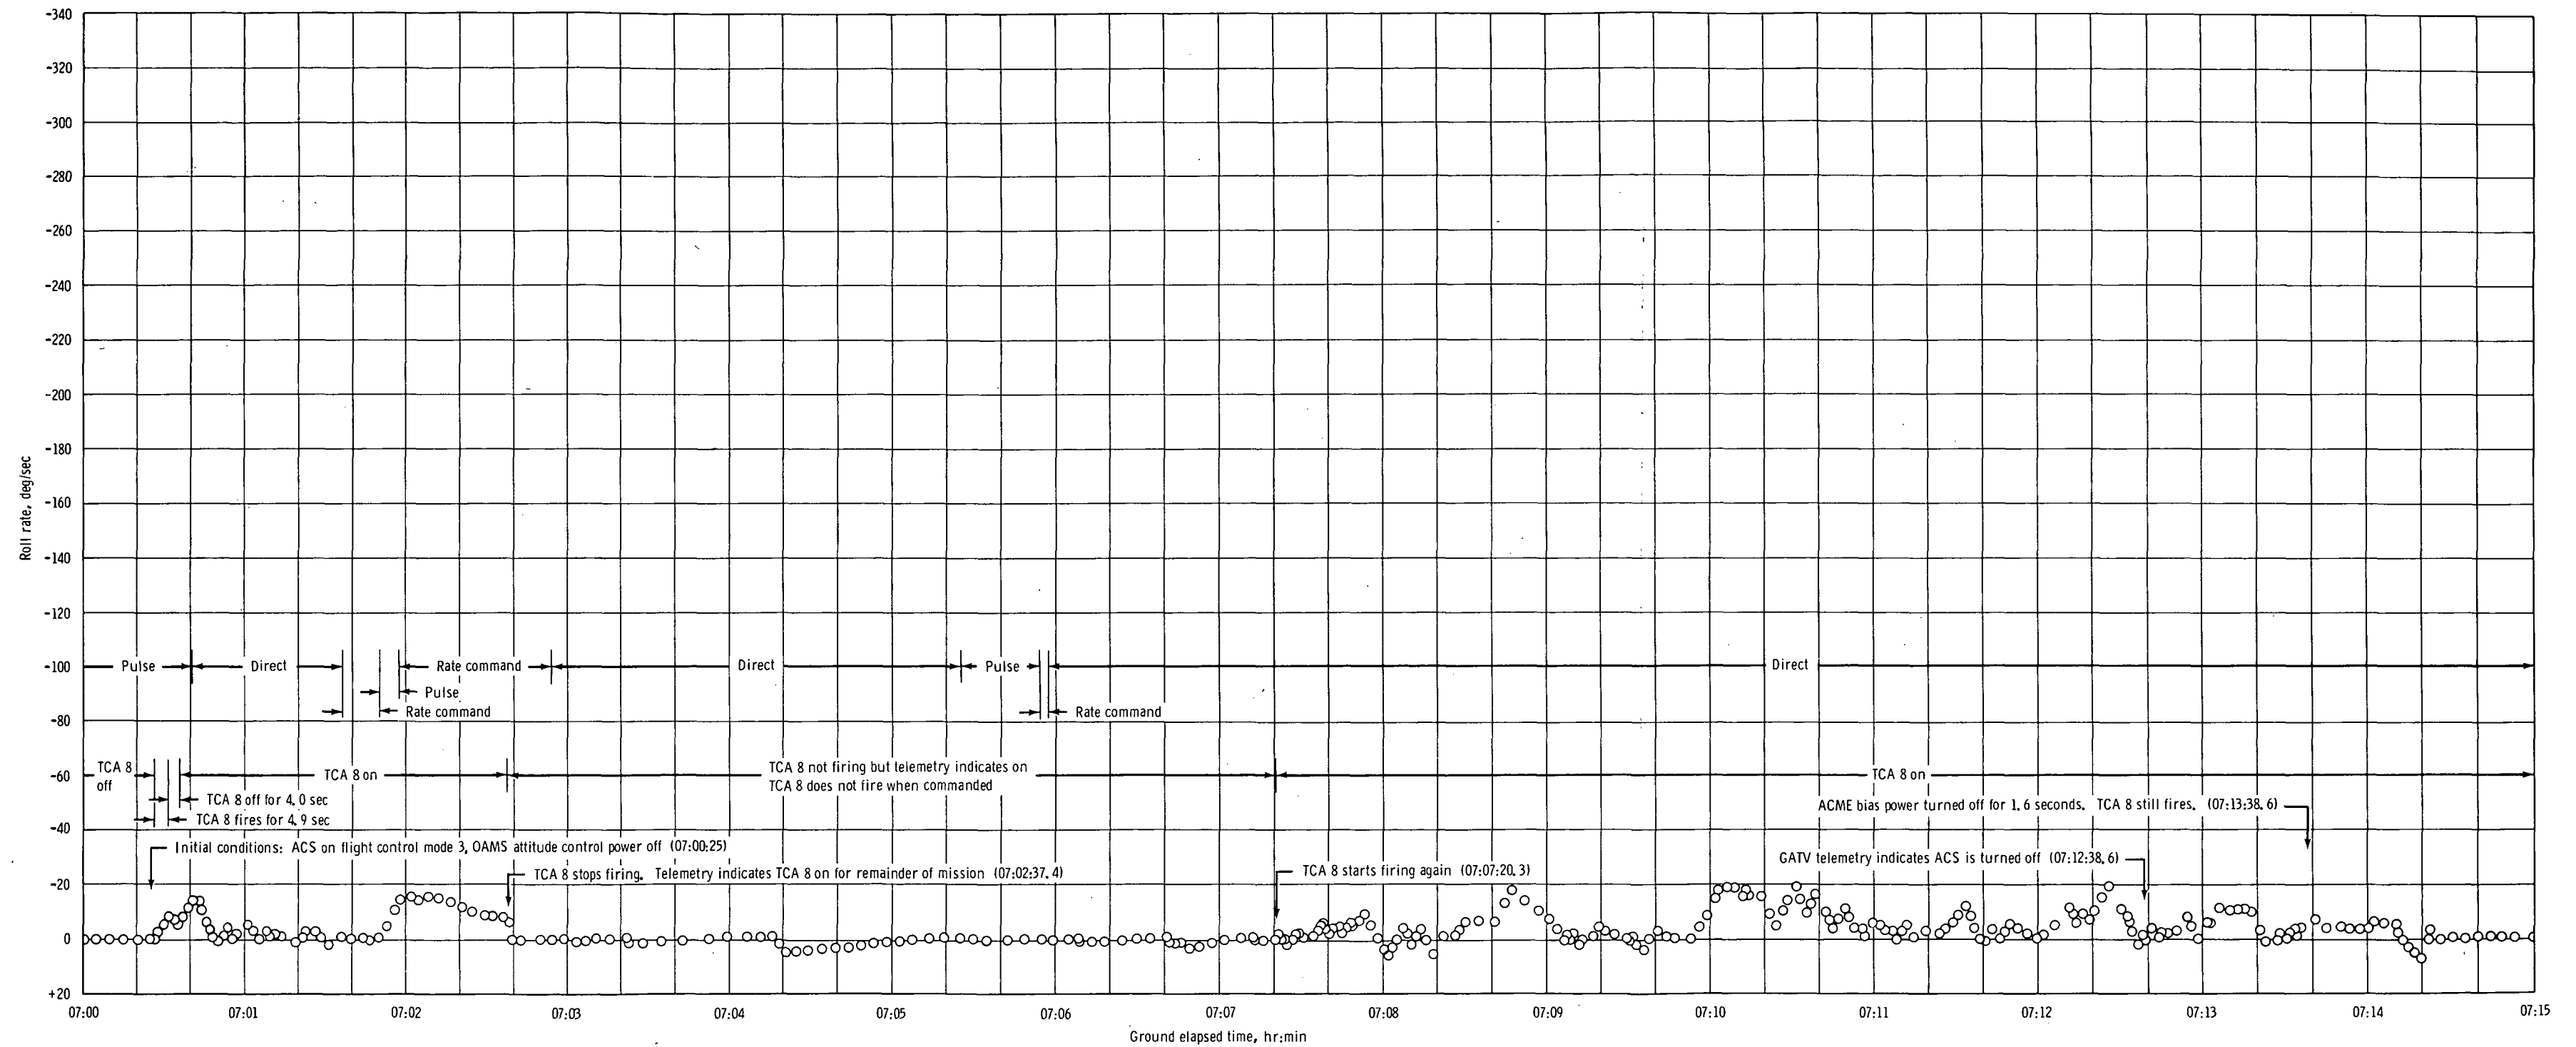
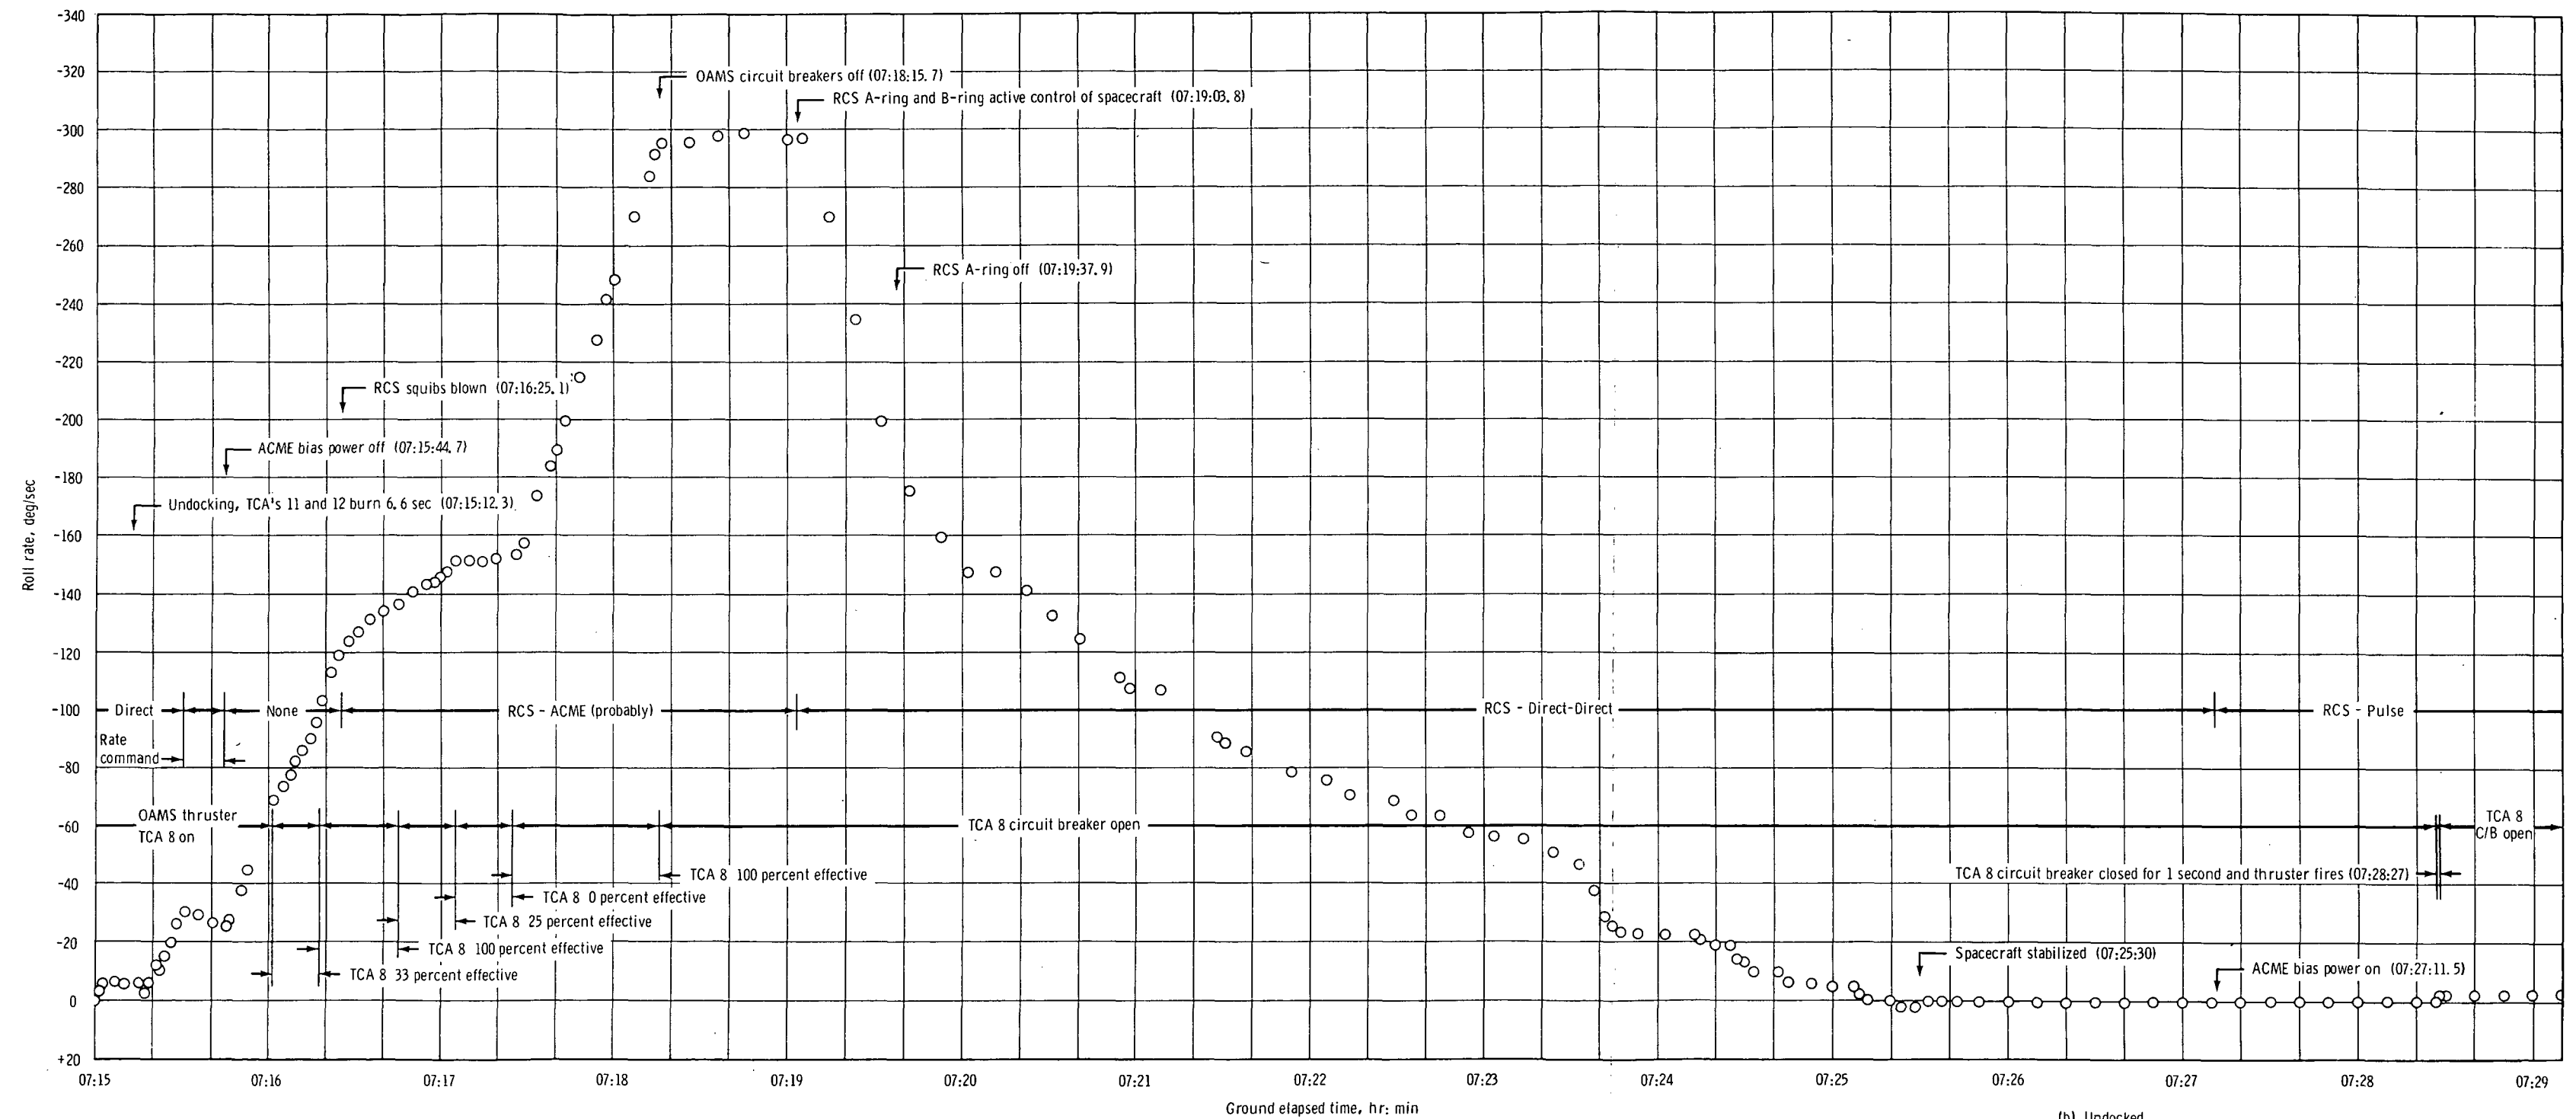
Figure 5, 1, 5-19, - Spacecraft roll rates during anomaly.

Figure 5.1.5-19 shows that nominal thrust was being produced by thruster 8 at the beginning of the failure period, 7:00:26 g.e.t., and during the firing at 7:17:30 g.e.t., just prior to opening the circuit breaker. However, during this interval, accelerations were indicated to be less than nominal in a few instances. In one case, thruster 8 ceased to fire while the spacecraft and the GATV were still docked, (from 7:02:37 to 7:07:20 g.e.t.), but a small roll acceleration reflecting a 0.5-pound disturbance force was recorded. This force was approximately the same as that produced by oxidizer flow alone; however, the corresponding yaw accelerations appeared to be lower than that expected. The value in yaw was very small and in the same order of magnitude as the accuracy of the data. Varying accelerations after undocking but prior to opening the circuit breakers are presumed to result from intermittent thruster firings or from closing and opening the motor valves; however, the crew did not report operating the motor valves at this time. The thrust levels of thruster 8 are believed to have been nominal whenever both propellant valves were open. This is based on the nominal accelerations measured just prior to opening the circuit breaker and on OAMS thruster lifetime capabilities.

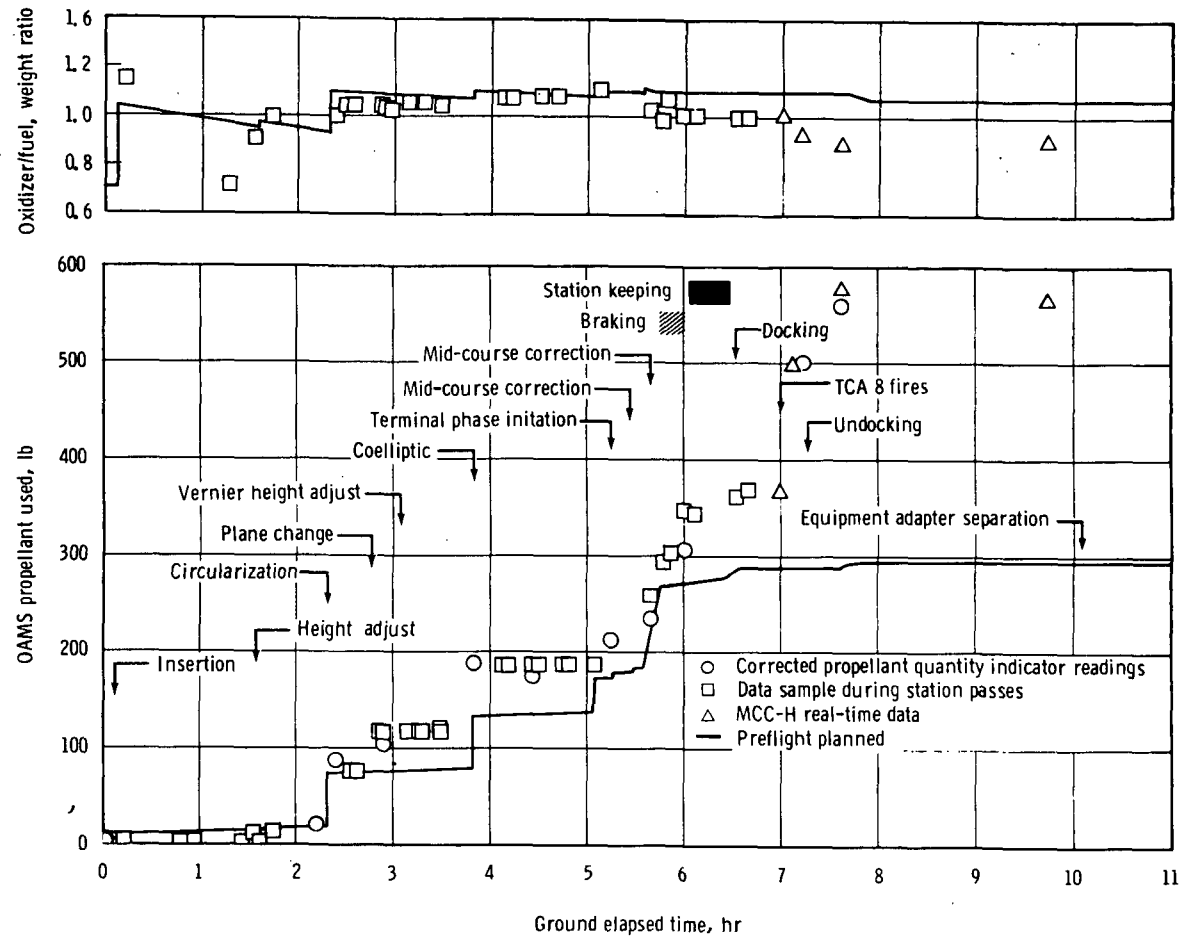
Figure 5.1.8-1 - OAMS propellant consumption.

A comparison of the two measurements of propellant quantity, PQI and the gaging equation, shows good agreement. The propellant required through docking was somewhat greater than the flight-plan estimates. This was caused partly by the added real-time requirement of a plan-change and a vernier height-adjust maneuver, which consumed 27.6 pounds of maneuver propellant. Additional quantities were also consumed because the maneuver firing durations were greater than planned due to the post-maneuver corrections discussed previously. The lower flight mixture ratio realized up through docking, as compared with the pre-flight estimates, indicates that more attitude propellant was required than had been planned.

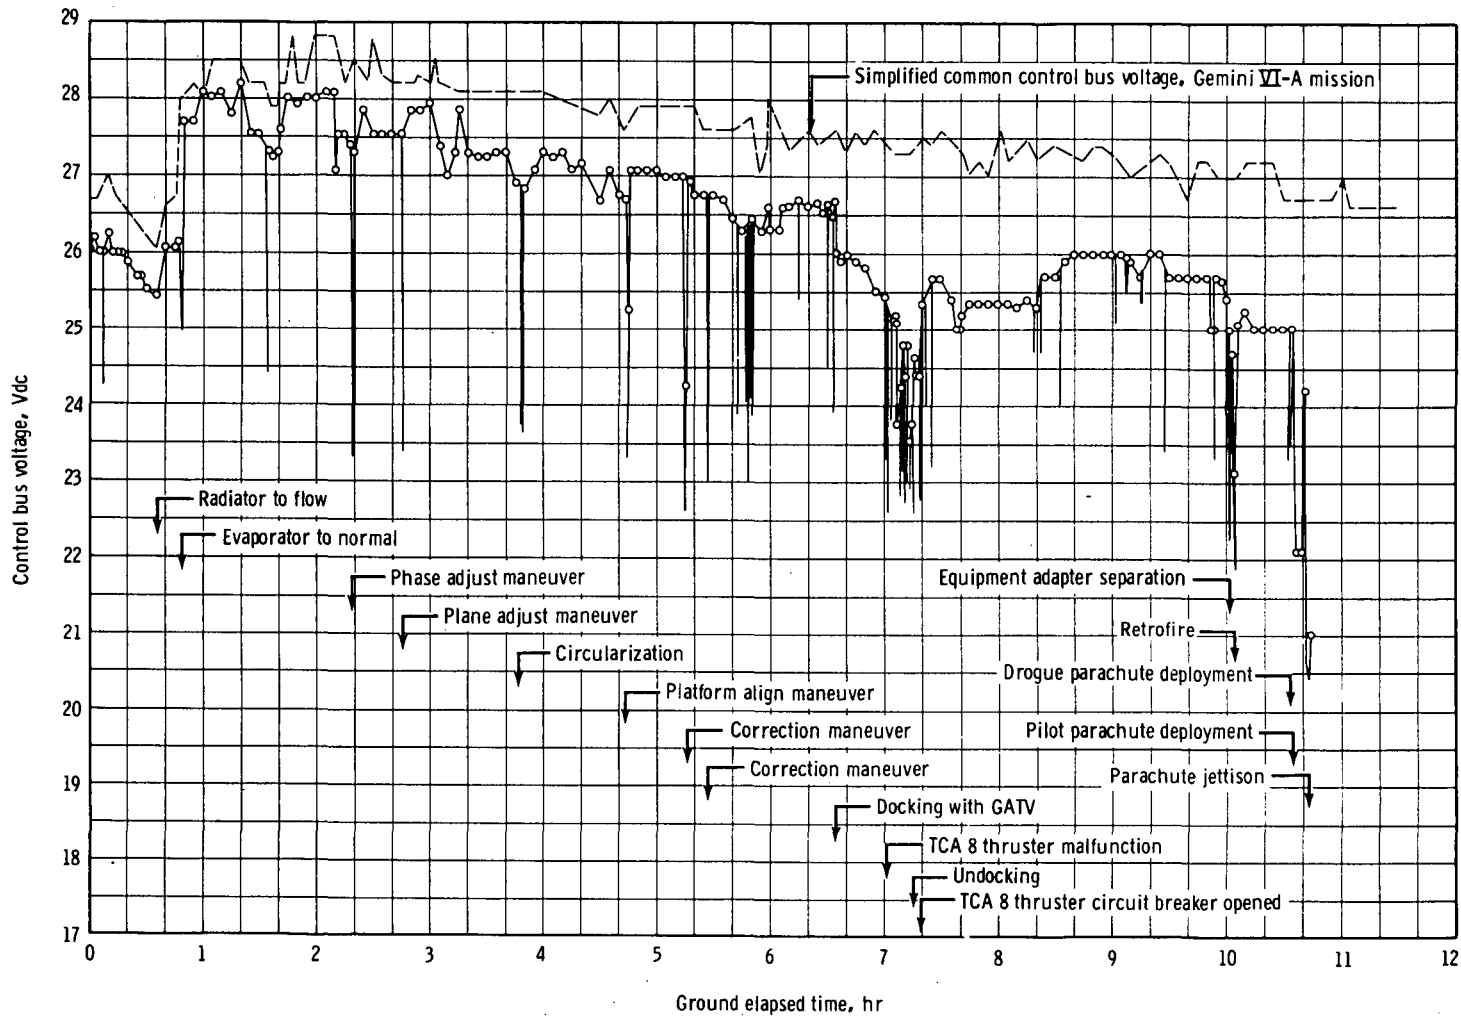
Figure 5.1.7-5 - Common control bus voltage performance.

(a) 7:00:26.7 to 7:02:37.4 g.e.t. - This period was characterized by voltage transients caused by thruster 8 first coming on, then going off, then staying on continuously, and by the counter thruster responses commanded by the flight crew.

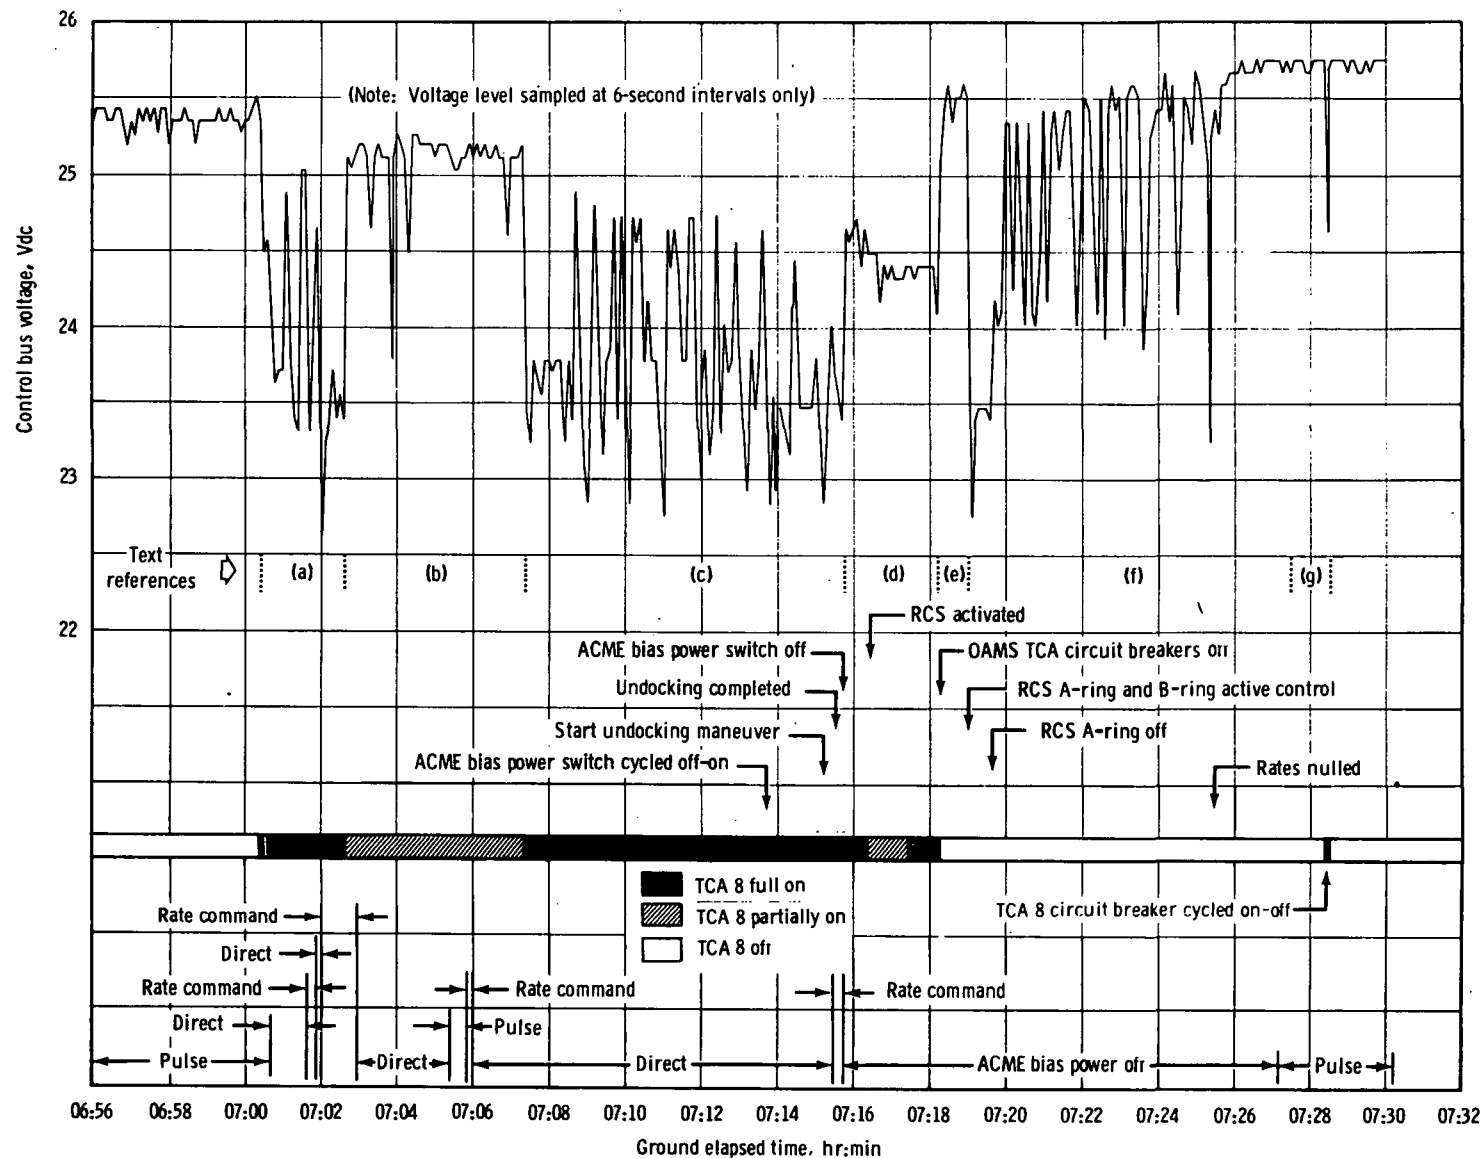
Figure 5.1.7-6 - Common control bus performance during OAMS thruster malfunction period.

(g) 7:25:30 to 7:28:30 g.e.t. - The flight crew reactivated the OAMS and found that thruster 8 would fire continuously when its circuit breaker was closed, even when the hand controller was in a neutral position. The voltage transient at 7:28:27 g.e.t. amounted to a depression of 1.25 volts in bus voltage when only the one thruster, no. 8, was firing.

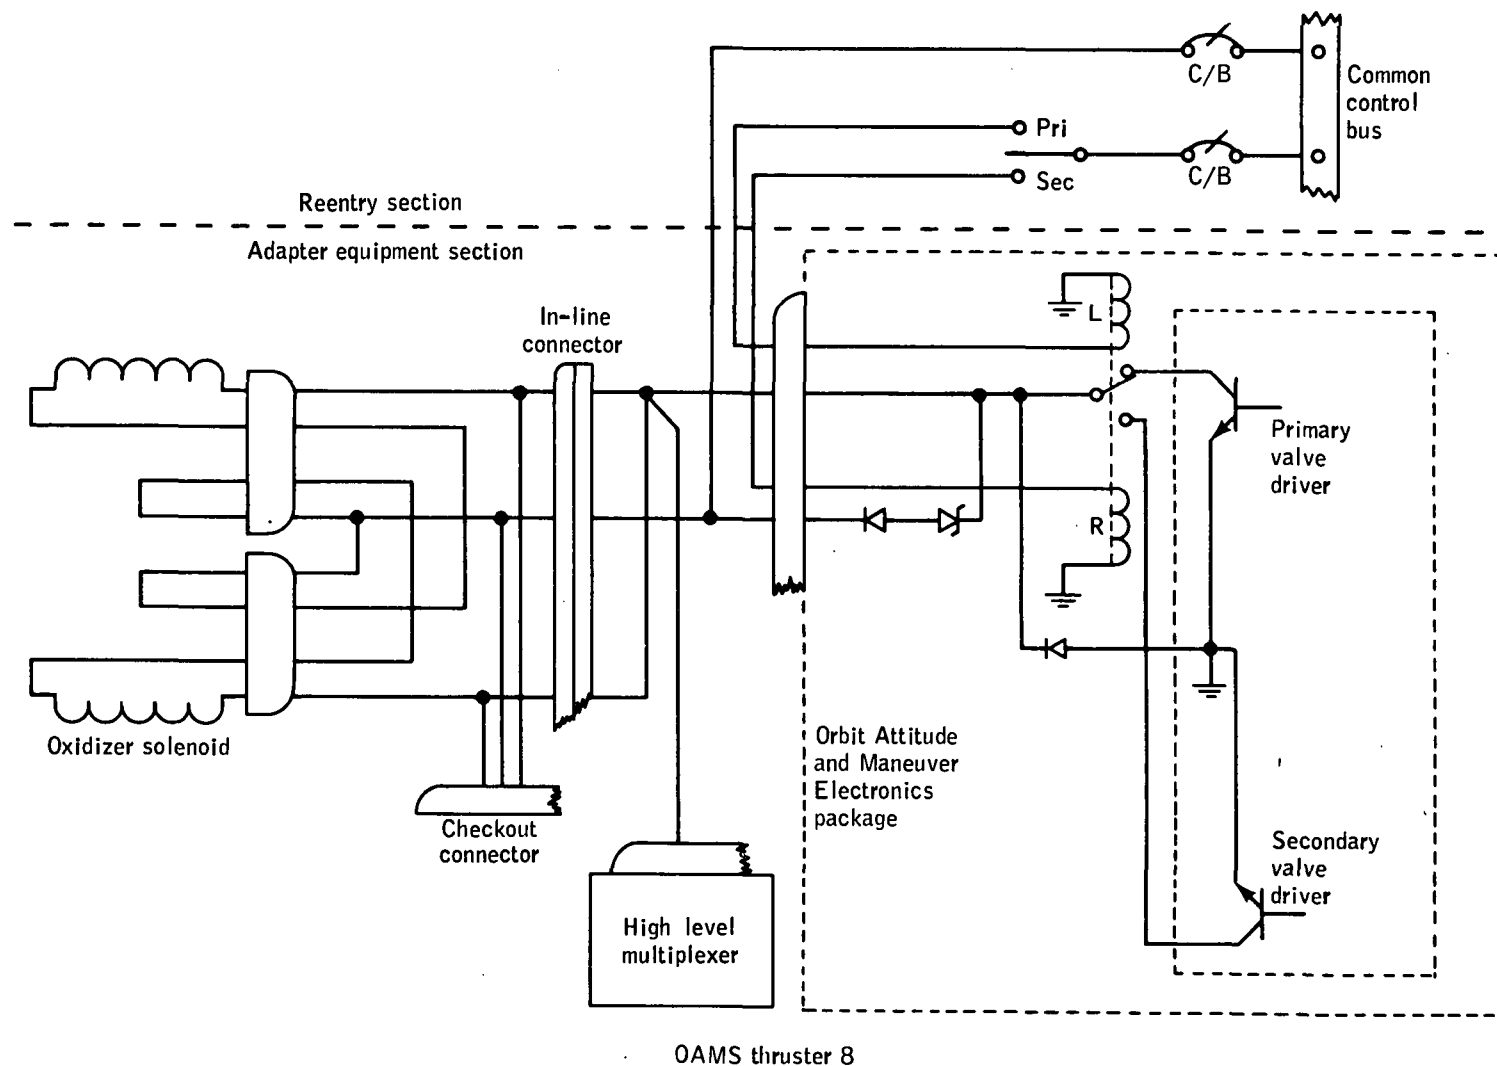
Figure 5.1.7-7 - Wiring schematic of critical area.

The circuits involved with the anomalous condition of the flight control system are shown in figure 5.1.7-7. The firing of the thrusters is normally accomplished by switching one end of each of the fuel and oxidizer solenoid coils to ground by means of transistor switches. The transistor switches are activated by logic circuits, commanded directly by the flight crew or automatically by the control system. Either primary or secondary transistor switching circuits may be selected by the crew.

It is evident from the above that the failure was in the solenoids or in the spacecraft wiring between the solenoids and the junction of the two solenoid ground returns.

Further isolation of the failure has met with little success. The fault is not a simple one; it must vary in resistance sufficiently to enable either or both thruster solenoids to fire and still meet the ON requirements of telemetry (less than 5 volts).

On Spacecraft 9 and subsequent spacecraft, the OAMS thrusters will be powered from a separate bus which will be armed and disarmed by a single switch. This will provide the crew with a rapid means of disabling all OAMS thrusters before dynamic rates have time to build up.
